Focused Site Inspection Prioritization Report

Illinois Brick Company - Yard #17

USEPA ID No. ILD ~~048-305-684~~  
980 606 503

September 5, 1995

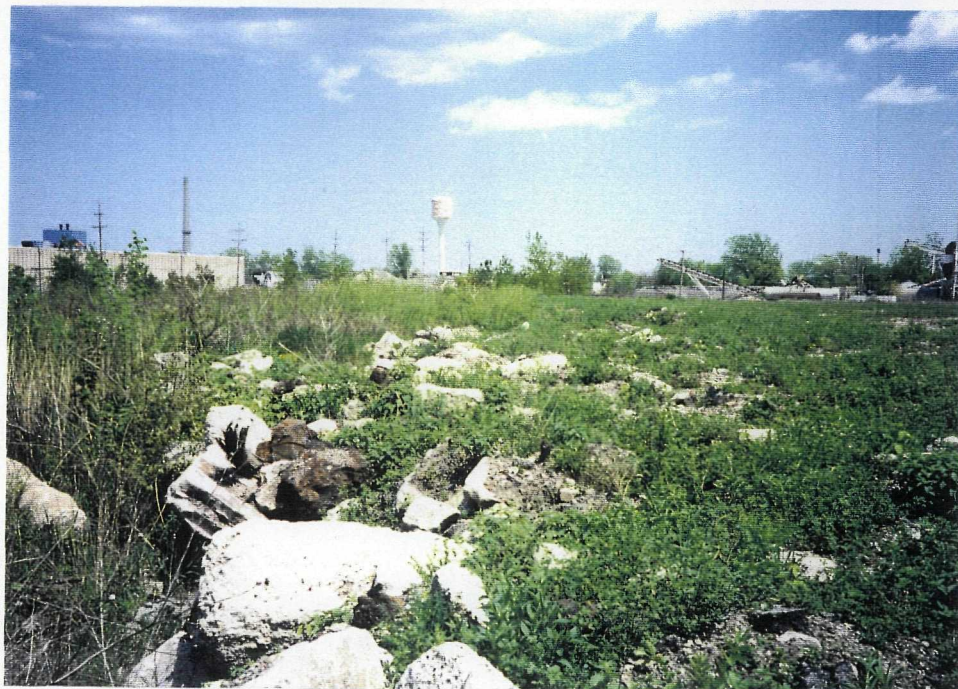
**Date:** May 19, 1995  
**Time:** 1336  
**Photo Taken By:** R. Reints  
**Photo Number:** 1  
**Site/ILD No.:** Illinois Brick  
Company - Yard #17/ILD  
980606503  
**Direction of Photo:** Facing  
east northeast.  
**Description:** In NW corner  
of site - broken concrete.

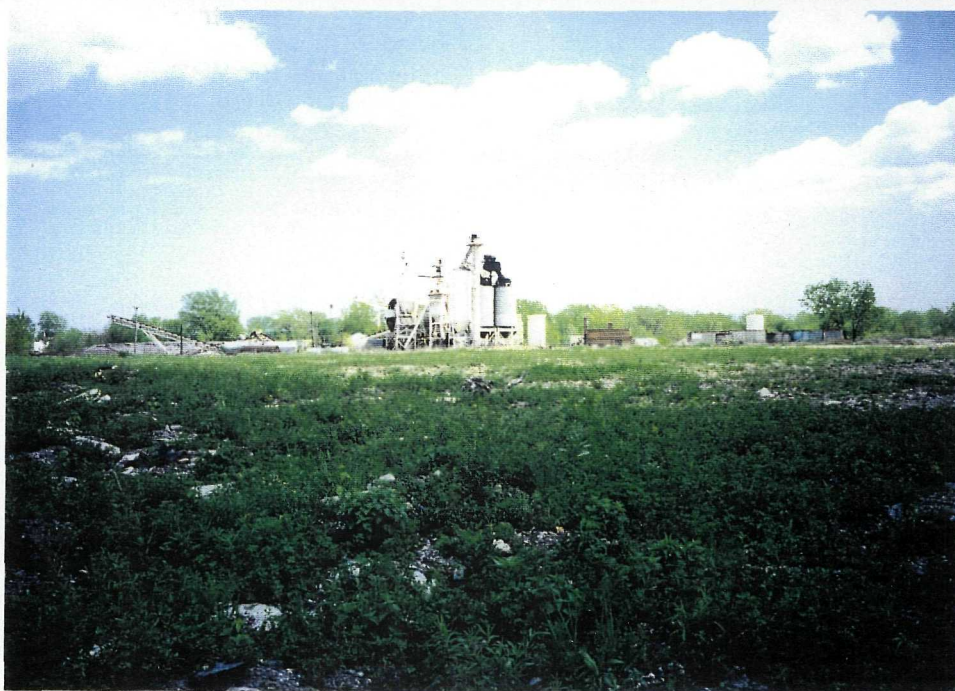
**Date:** May 19, 1995  
**Time:** 1336  
**Photo Taken By:** R. Reints  
**Photo Number:** 2  
**Site/ILD No.:** Illinois Brick  
Company - Yard #17/ILD  
980606503  
**Direction of Photo:** Facing  
east.  
**Description:** In NW corner  
- Gallagher Asphalt from  
across the site.

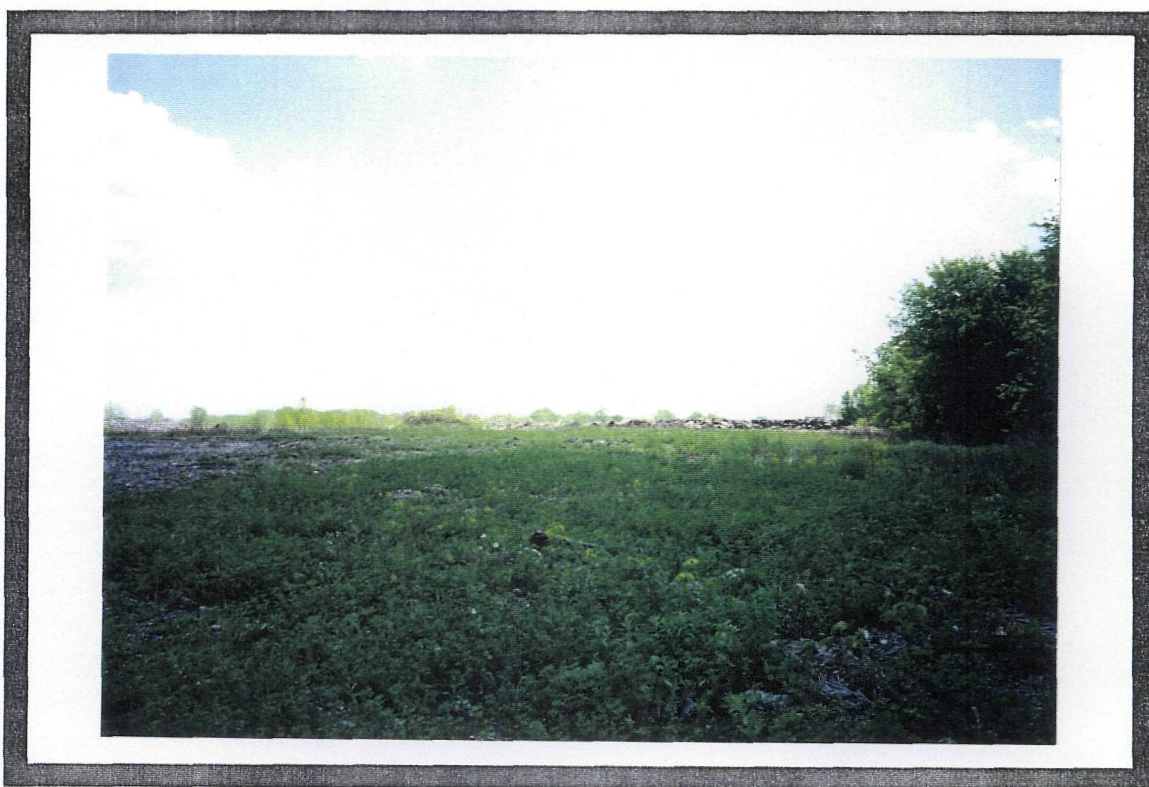
**Date:** May 19, 1995  
**Time:** 1336  
**Photo Taken By:** R. Reints  
**Photo Number:** 3  
**Site/ILD No.:** Illinois Brick  
Company - Yard #17/ILD  
980606503  
**Direction of Photo:** Facing  
east southeast.  
**Description:** In NW corner.  
View of the north part of the  
west parcel.

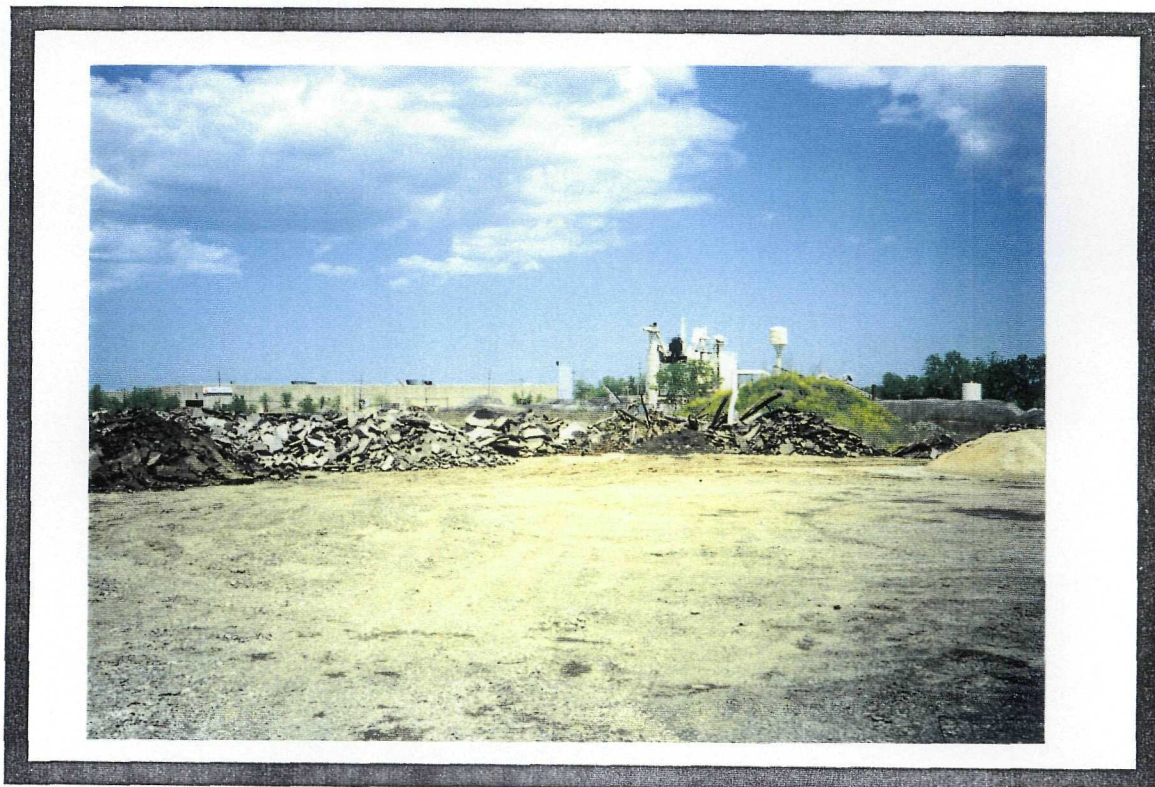
**Date:** May 19, 1995  
**Time:** 1342  
**Photo Taken By:** R. Reints  
**Photo Number:** 4  
**Site/ILD No.:** Illinois Brick  
Company - Yard #17/ILD  
980606503  
**Direction of Photo:** Facing  
northeast.  
**Description:** Asphalt in  
west parcel - central part of  
parcel.

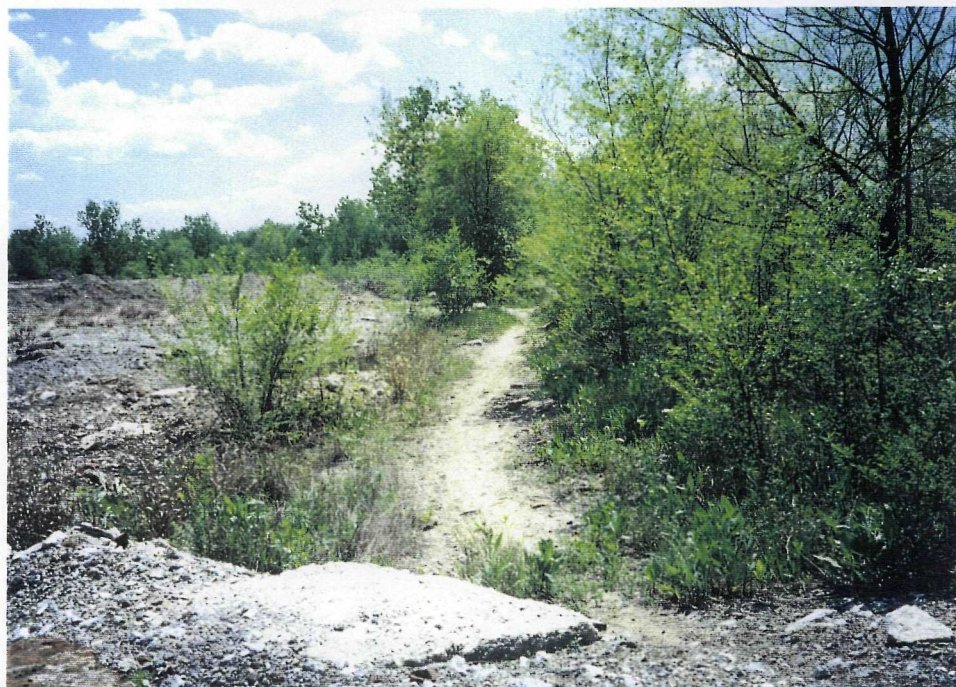
**Date:** May 19, 1995  
**Time:** 1346  
**Photo Taken By:** R. Reints  
**Photo Number:** 5  
**Site/ILD No.:** Illinois Brick  
Company - Yard #17/ILD  
980606503  
**Direction of Photo:** Facing  
south.  
**Description:** West parcel.  
Bike path, black chips on  
ground as per SSI notes.

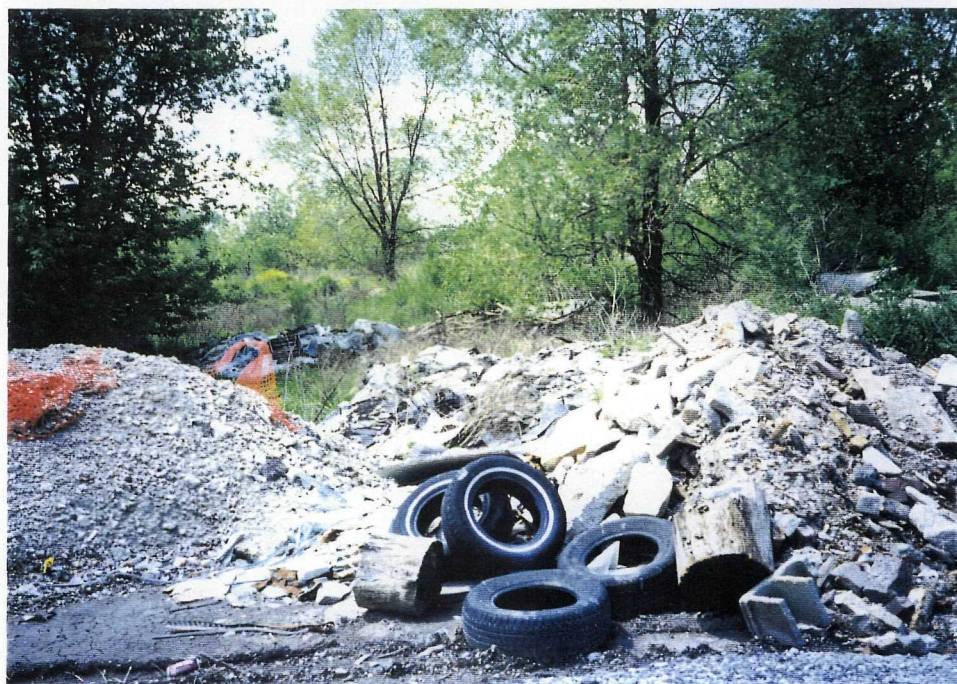
**Date:** May 19, 1995  
**Time:** 1357  
**Photo Taken By:** R. Reints  
**Photo Number:** 6  
**Site/ILD No.:** Illinois Brick  
Company - Yard #17/ILD  
980606503  
**Direction of Photo:** Facing  
west.  
**Description:** Miscellaneous  
trash, at south end of west  
parcel.

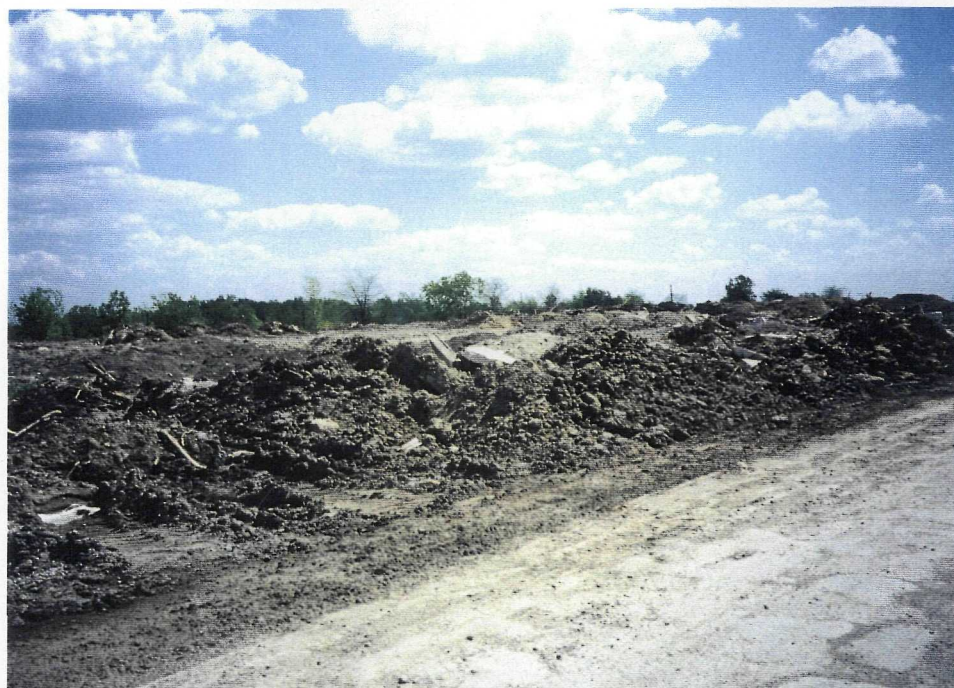
**Date:** May 19, 1995  
**Time:** 1403  
**Photo Taken By:** R. Reints  
**Photo Number:** 7  
**Site/ILD No.:** Illinois Brick  
Company - Yard #17/ILD  
980606503  
**Direction of Photo:** Facing  
south southeast.  
**Description:** From Division  
St., middle parcel. Berm,  
then piled fill.

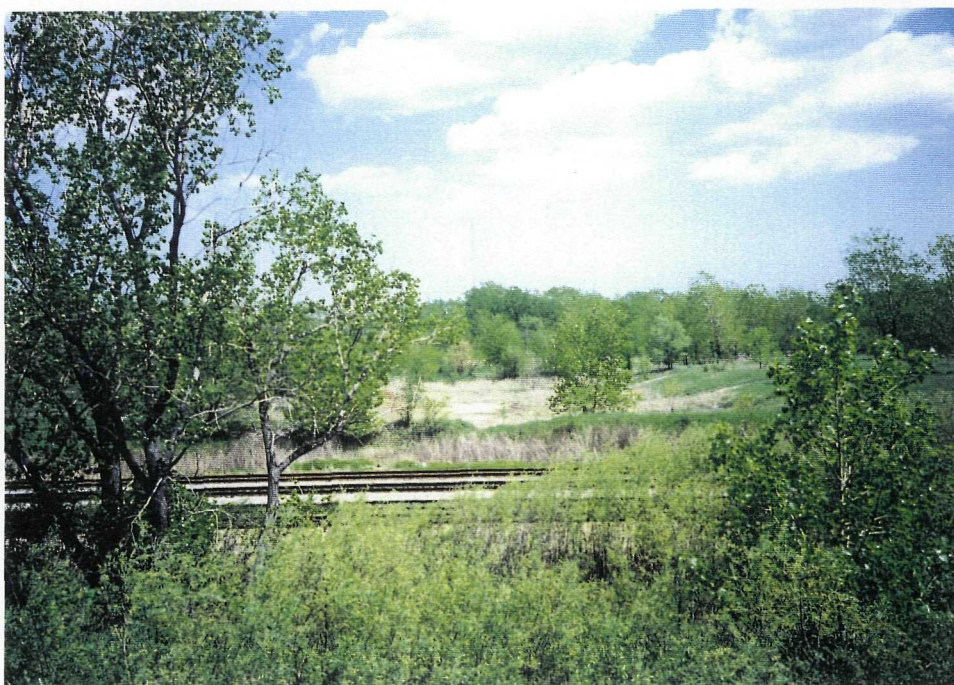
**Date:** May 19, 1995  
**Time:** 1407  
**Photo Taken By:** R. Reints  
**Photo Number:** 8  
**Site/ILD No.:** Illinois Brick  
Company - Yard #17/ILD  
980606503  
**Direction of Photo:** Facing  
east.  
**Description:** East-most  
parcel from asphalt pile.

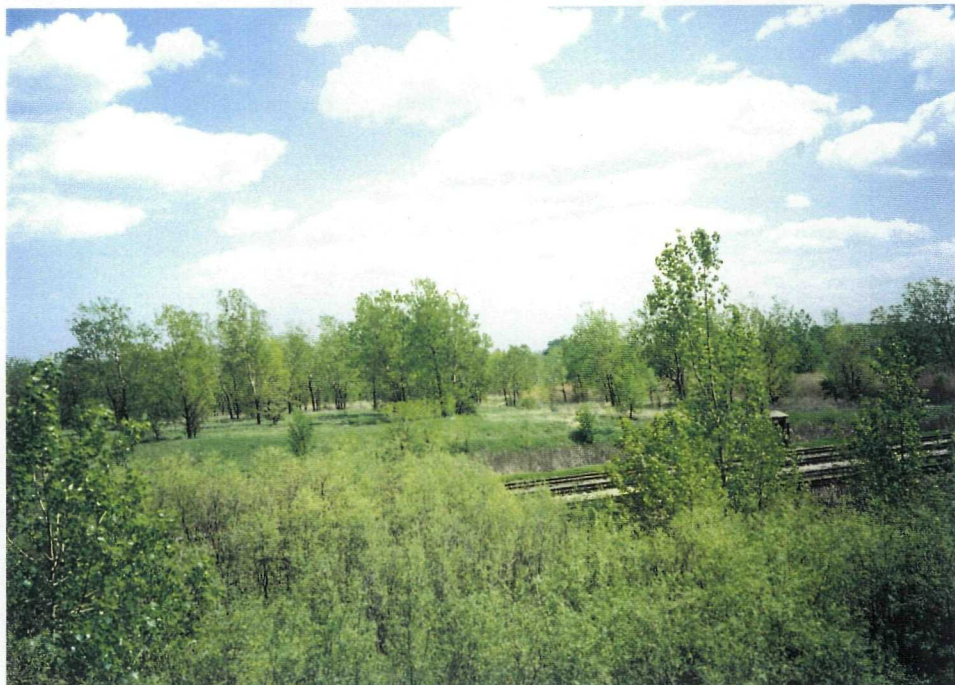
**Date:** May 19, 1995  
**Time:** 1407  
**Photo Taken By:** R. Reints  
**Photo Number:** 9  
**Site/ILD No.:** Illinois Brick  
Company - Yard #17/ILD  
980606503  
**Direction of Photo:** Facing  
east southeast.  
**Description:** East-most  
parcel from asphalt pile.

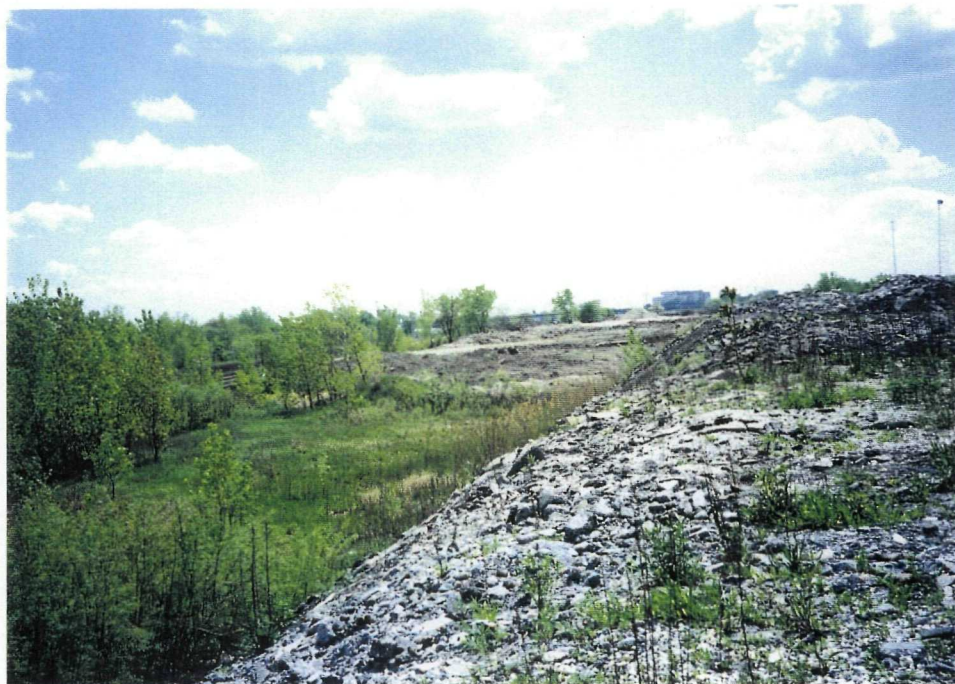
**Date:** May 19, 1995  
**Time:** 1407  
**Photo Taken By:** R. Reints  
**Photo Number:** 10  
**Site/ILD No.:** Illinois Brick  
Company - Yard #17/ILD  
980606503  
**Direction of Photo:** Facing  
south southeast.  
**Description:** Middle piece  
from asphalt pile.

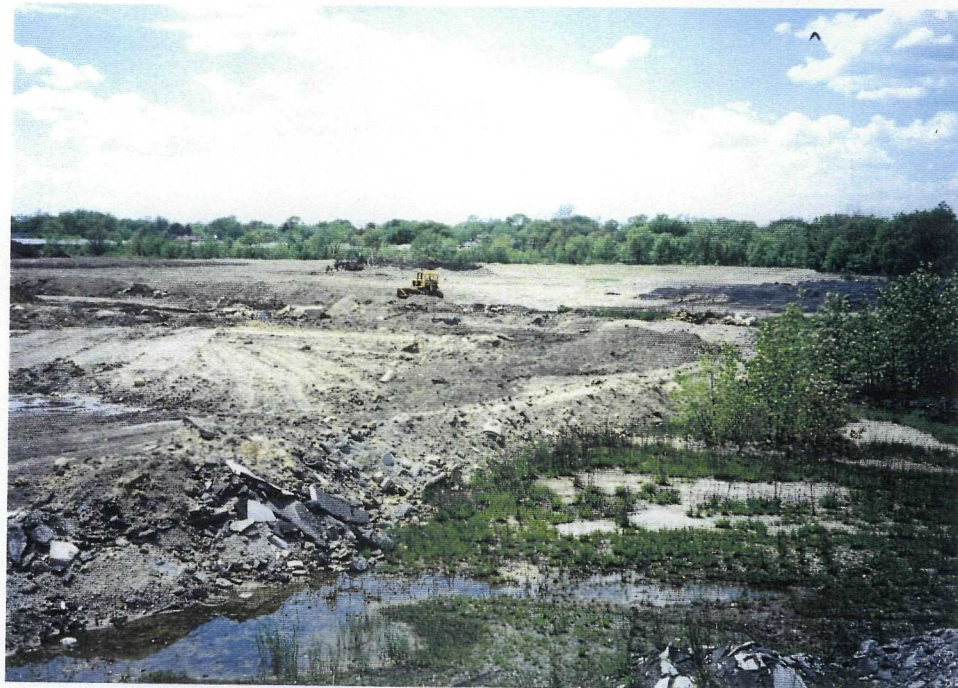
Date: May 19, 1995  
Time: 1410  
Photo Taken By: R. Reints  
Photo Number: 11  
Site/ILD No.: Illinois Brick  
Company - Yard #17/ILD  
980606503  
Direction of Photo: Facing  
northwest.  
Description: Middle and  
west properties.

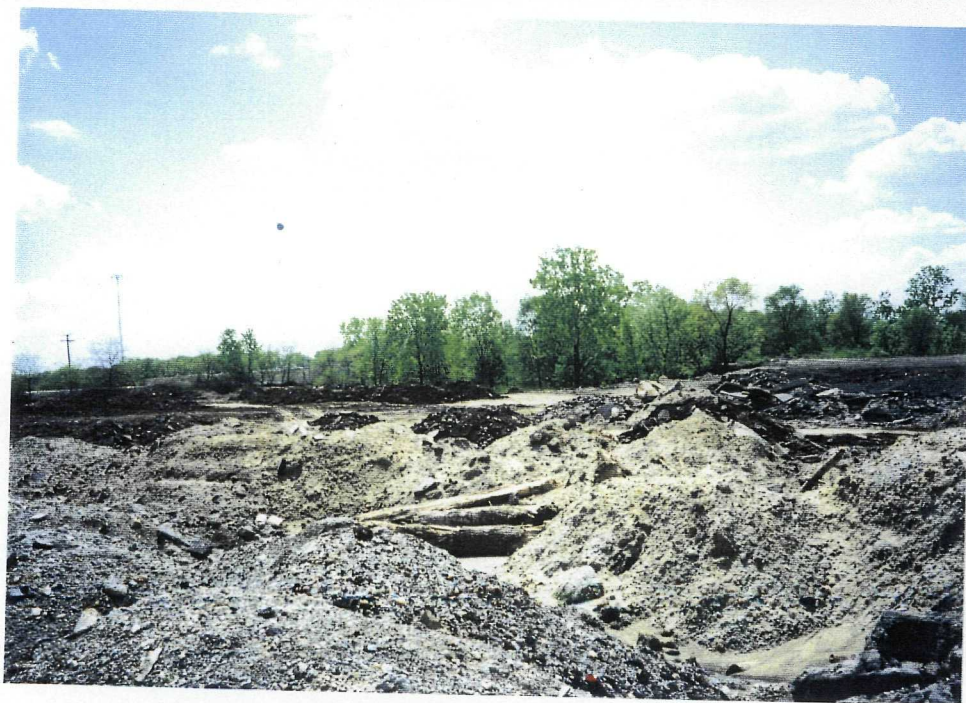
Date: May 19, 1995  
Time: 1417  
Photo Taken By: R. Reints  
Photo Number: 12  
Site/ILD No.: Illinois Brick  
Company - Yard #17/ILD  
980606503  
Direction of Photo: Facing  
southwest.  
Description: South end of  
middle parcel.

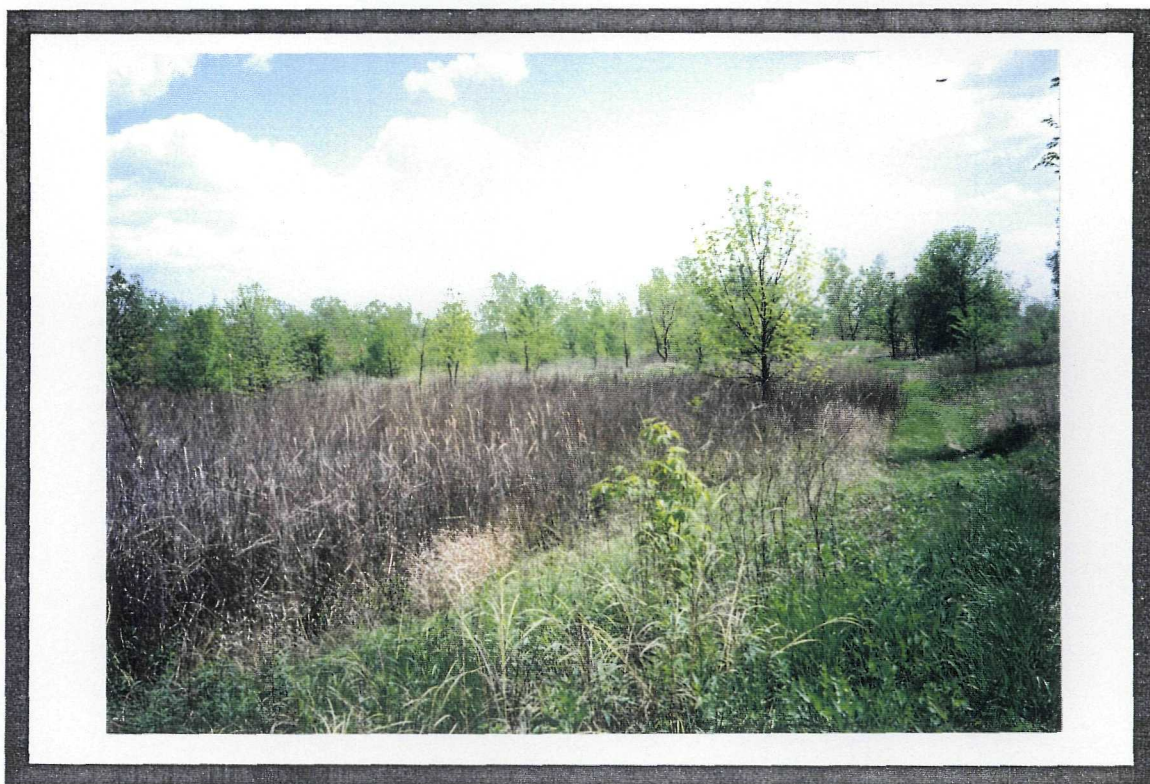
The site is accessible, although ditches and berms are present along a portion of the site boundary. Sexton is presently capping a portion of the site with clay. There is evidence of recreational use in the non-active areas, since motorcycle and dirt bike trails were noted. The surrounding area is urban. A cover is maintained over the landfilled

Date: May 19, 1995  
Time: 1445  
Photo Taken By: R. Reints  
Photo Number: 13  
Site/ILD No.: Illinois Brick  
Company - Yard #17/ILD  
980606503  
Direction of Photo: Facing  
south southeast.  
Description: East parcel.  
Note trails.

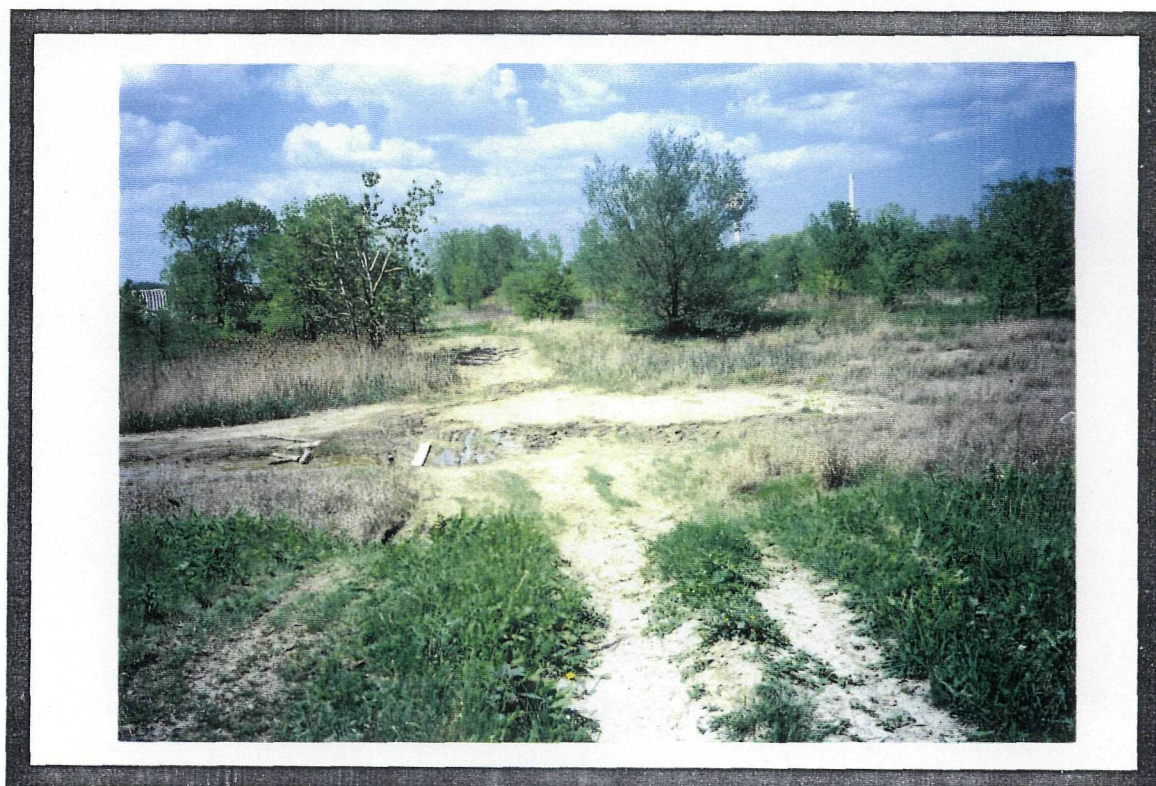
Date: May 19, 1995  
Time: 1451  
Photo Taken By: R. Reints  
Photo Number: 14  
Site/ILD No.: Illinois Brick  
Company - Yard #17/ILD  
980606503  
Direction of Photo: Facing  
north northeast.  
Description: Trail bike area.

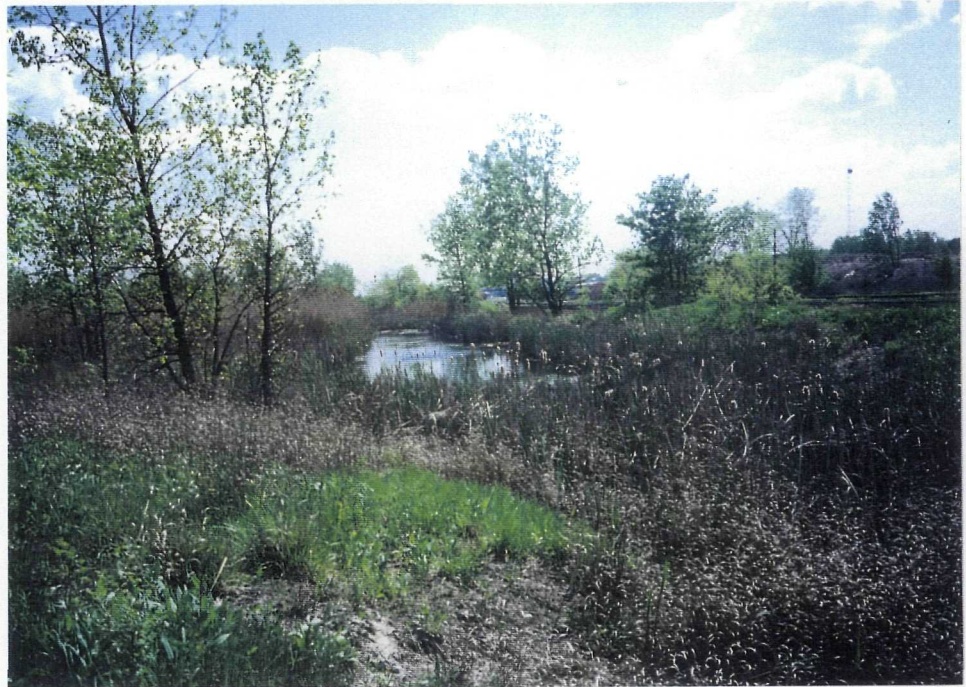
Date: May 19, 1995  
Time: 1453  
Photo Taken By: R. Reints  
Photo Number: 15  
Site/ILD No.: Illinois Brick  
Company - Yard #17/ILD  
980606503  
Direction of Photo: Facing  
south.  
Description: Open water  
and cattails.

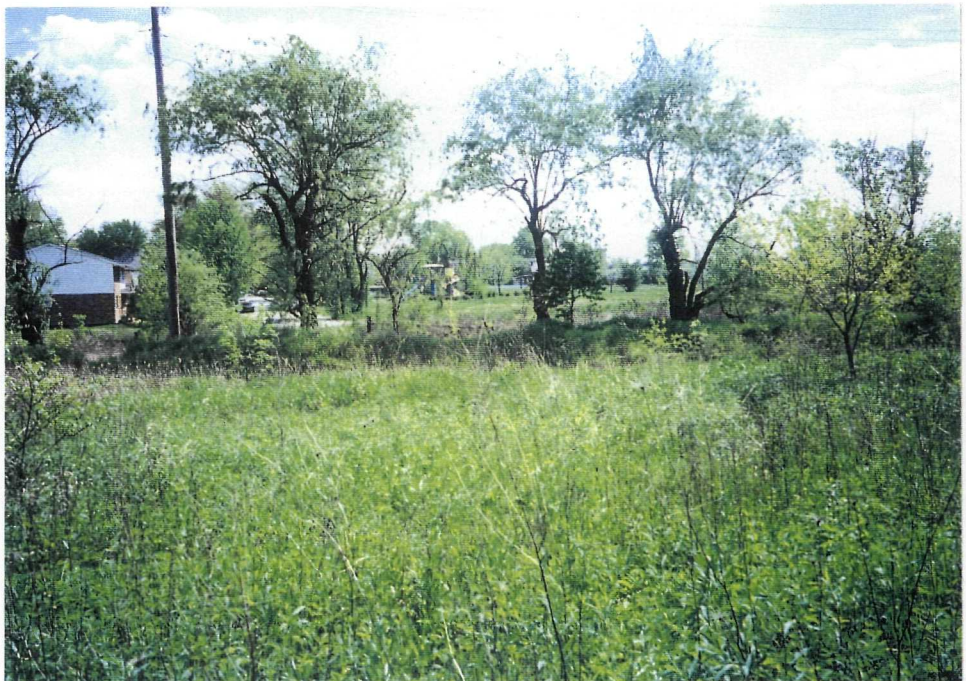
Date: May 19, 1995  
Time: 1500  
Photo Taken By: R. Reints  
Photo Number: 16  
Site/ILD No.: Illinois Brick  
Company - Yard #17/ILD  
980606503  
Direction of Photo: Facing  
south.  
Description: Toward  
Troublemakers Park.

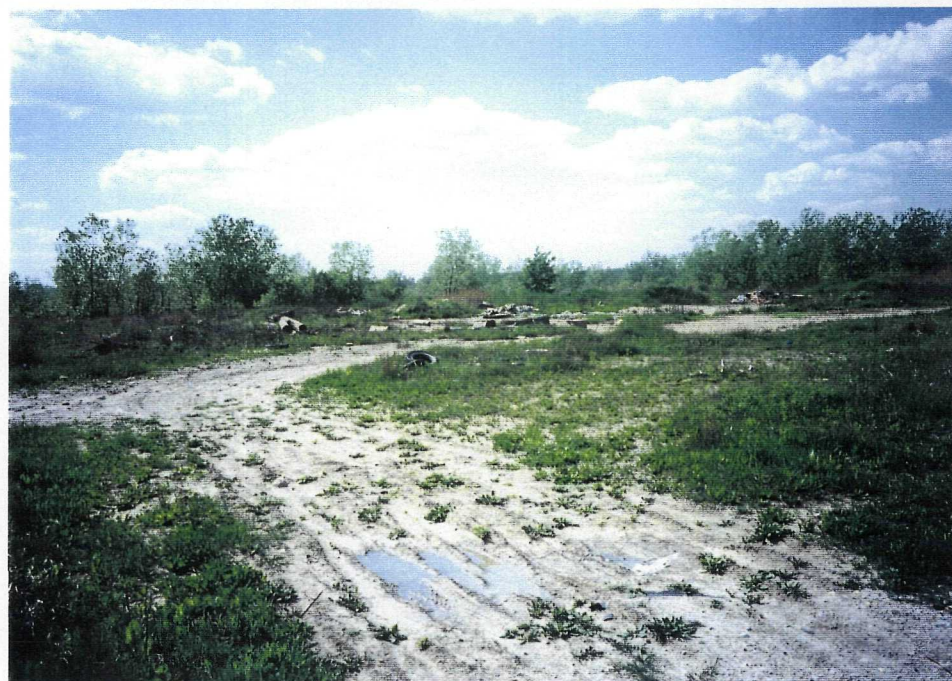
**Date:** May 19, 1995  
**Time:** 1514  
**Photo Taken By:** R. Reints  
**Photo Number:** 18  
**Site/ILD No.:** Illinois Brick  
Company - Yard #17/ILD  
980606503  
**Direction of Photo:** Facing  
northwest.  
**Description:** Southeast  
corner of east corner.
